DRAINAGE INVESTIGATION (Build Over) REPORT

Risk Address: 111 Smiths Way, Neverland, CV1 111

Report Reference: RWS00111

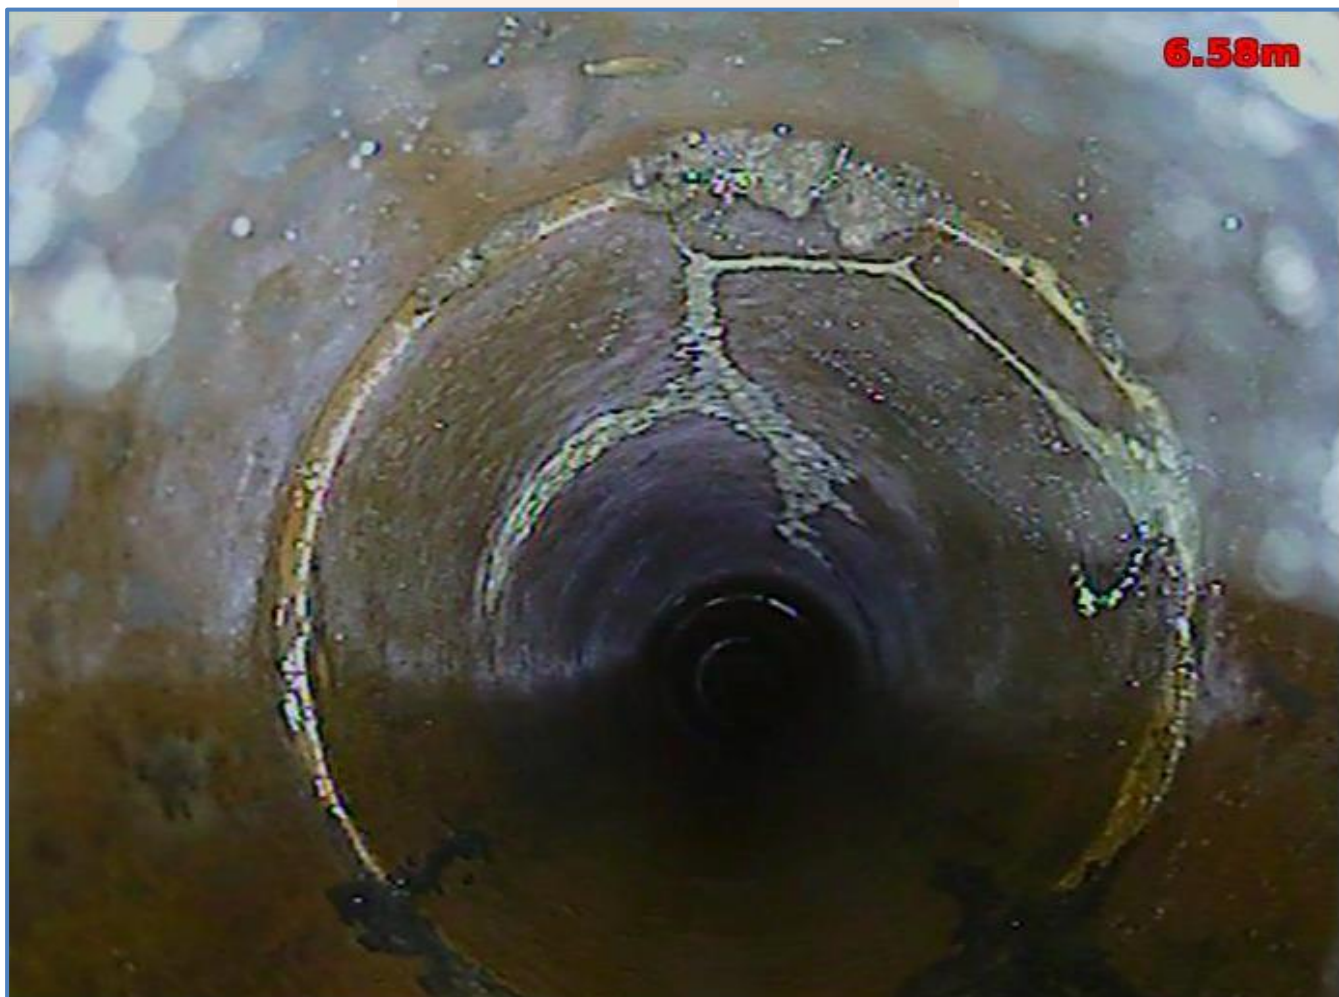
RUN A Multiple Cracks at 6.58m

CCTV Survey Result: Structural Damage - Multiple Cracks at 6.58m

Condition Grade: B

1) To prepare the drain line and insert 1x (100mmØ) resin patch liner to cover defect at 6.58m.
