# Drainage Report

**24 Example Street  
Birmingham  
B12 3PP**

CCTV Survey Report : 21/03/22

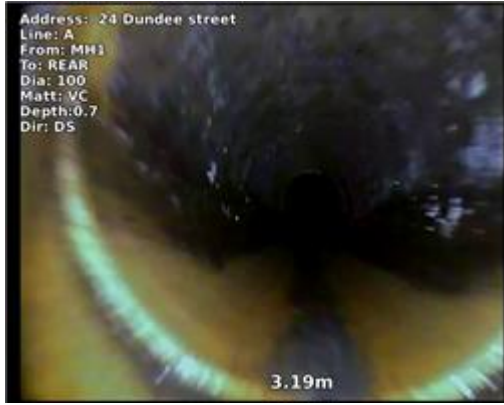
CCTV Survey Result: The survey revealed a displaced joint and broken pipework within the private section prior to the boundary.

<p>Address: 24 Dundee street Line: A From: MH1 To: REAR Dia: 100 Matt: VC Depth:0.7 Dir: DS</p> <p>0.08m</p>
00.00m	0:00:00	WL	Water level: 0% Height/Diameter	
03.19m	0:00:10	JDM	Joint displaced medium - Severity 3	<p>Image Provided - Ref: 0_2</p>

- 1) Carry out jetting prior to lining
- 2) Install up to 4m of liner to cover defects

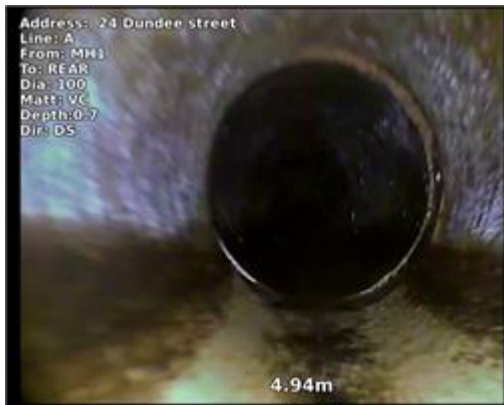
<p>Address: 24 Dundee street Line: A From: MH1 To: REAR Dia: 100 Matt: VC Depth:0.7 Dir: DS</p> <p>3.19m</p>
04.94m	0:00:14	B	Broken pipe from 03 o'clock to 07 o'clock - Severity 4	<p>Image Provided - Ref: 0_3</p>

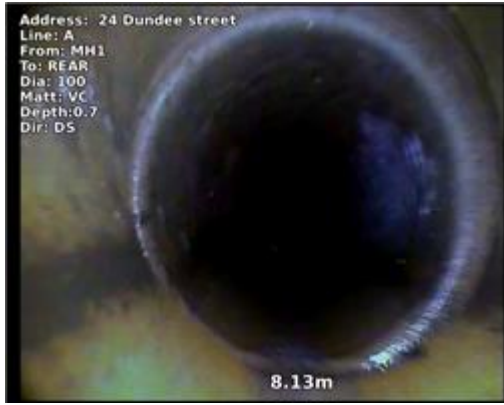
Pos	Video Ref	Code	Description	Image
08.13m	0:00:22	B	Broken pipe from 12 o'clock to 04 o'clock - Severity 4	<p>Image Provided - Ref: 0_4</p>

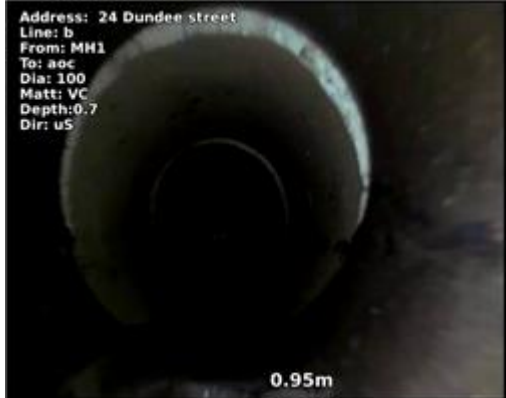
CCTV Survey Result: The survey revealed displaced joints and scale.

00.00m	0:00:00	WL	Water level: 0% Height/Diameter	
00.95m	0:00:02	JDM	Joint displaced medium - Severity 3	<p>Image Provided - Ref: 1_2</p>

- 1) Excavate and replace rest bend at WC
- 2) Excavate and replace 1m of pipework
- 3) Install up to 2m of flexi liner to cover defects
- 4) Back-fill, reinstate and dispose of waste

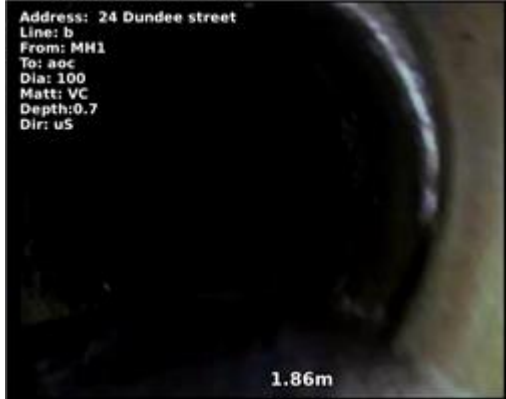
01.86m	0:00:05	JDM	Joint displaced medium - Severity 3	<p>Image Provided - Ref: 1_3</p>

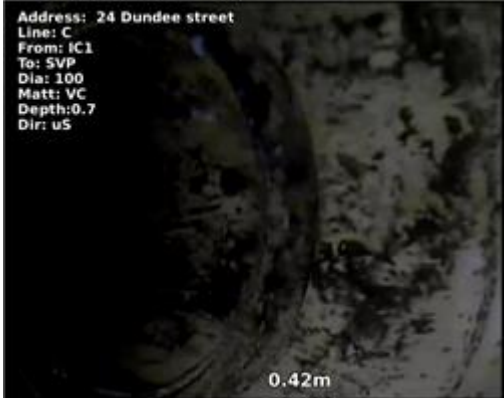
00.00m	0:00:00	WL	Water level: 0% Height/Diameter	
00.42m	0:00:01	LLF	Line of drain/sewer deviates left [full]	<p>Image Provided - Ref: 2_2</p>

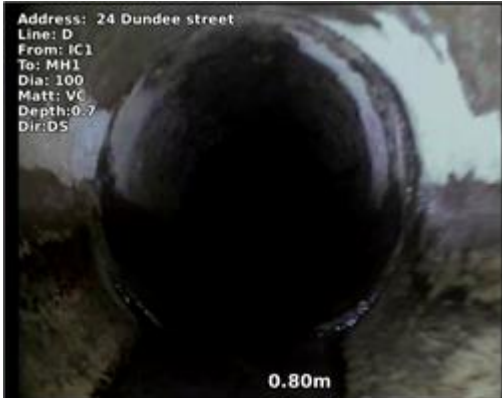
CCTV Survey Result: The survey revealed displaced joints.

<p>Address: 24 Dundee street Line: D From: IC1 To: MH1 Dia: 100 Matt: VC Depth:0.7 Dir:DS</p> <p>0.23m</p>
00.80m	0:00:04	JDM	Joint displaced medium - Severity 3	<p>Image Provided - Ref: 3_5</p>

- 1) Install up to 5m of flexi liner (minding the junction at 2.39m) to cover defects

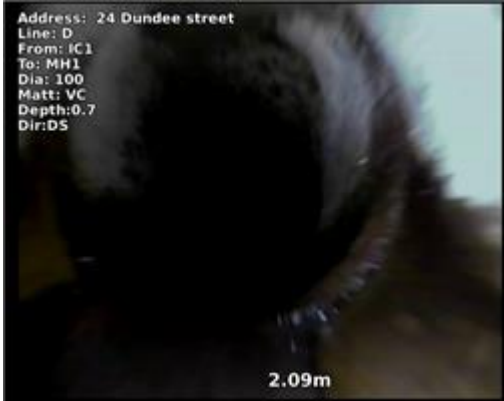
Pos	Video Ref	Code	Description	Image
02.09m	0:00:09	JDM	Joint displaced medium - Severity 3	<p>Image Provided - Ref: 3_6</p>

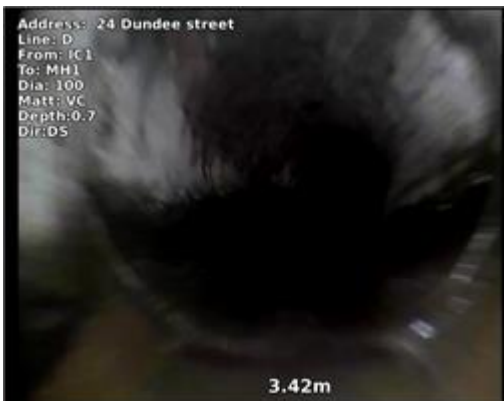
03.42m	0:00:13	JDM	Joint displaced medium - Severity 3	<p>Image Provided - Ref: 3_7</p>

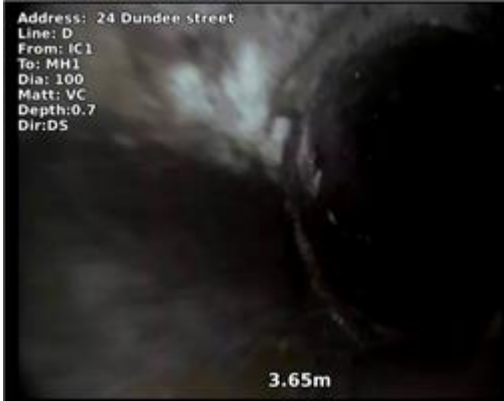
Pos	Video Ref	Code	Description	Image
03.65m	0:00:14	LRH	Line of drain/sewer deviates right [half]	<p>Image Provided - Ref: 3_4</p>

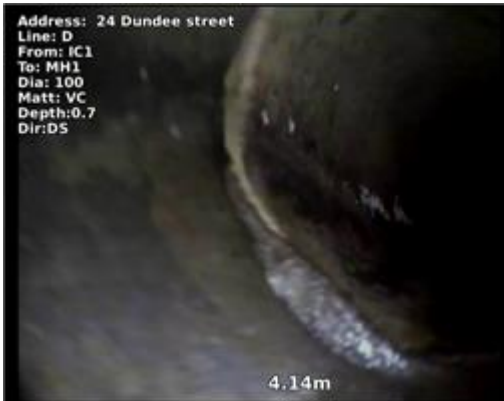
04.14m	0:00:16	JDM	Joint displaced medium - Severity 3	<p>Image Provided - Ref: 3_8</p>
