DRAINAGE INVESTIGATION (Build Over) REPORT

Risk Address: 111 Smiths Way, Neverland, CV1 111

Report Reference: RWS00111

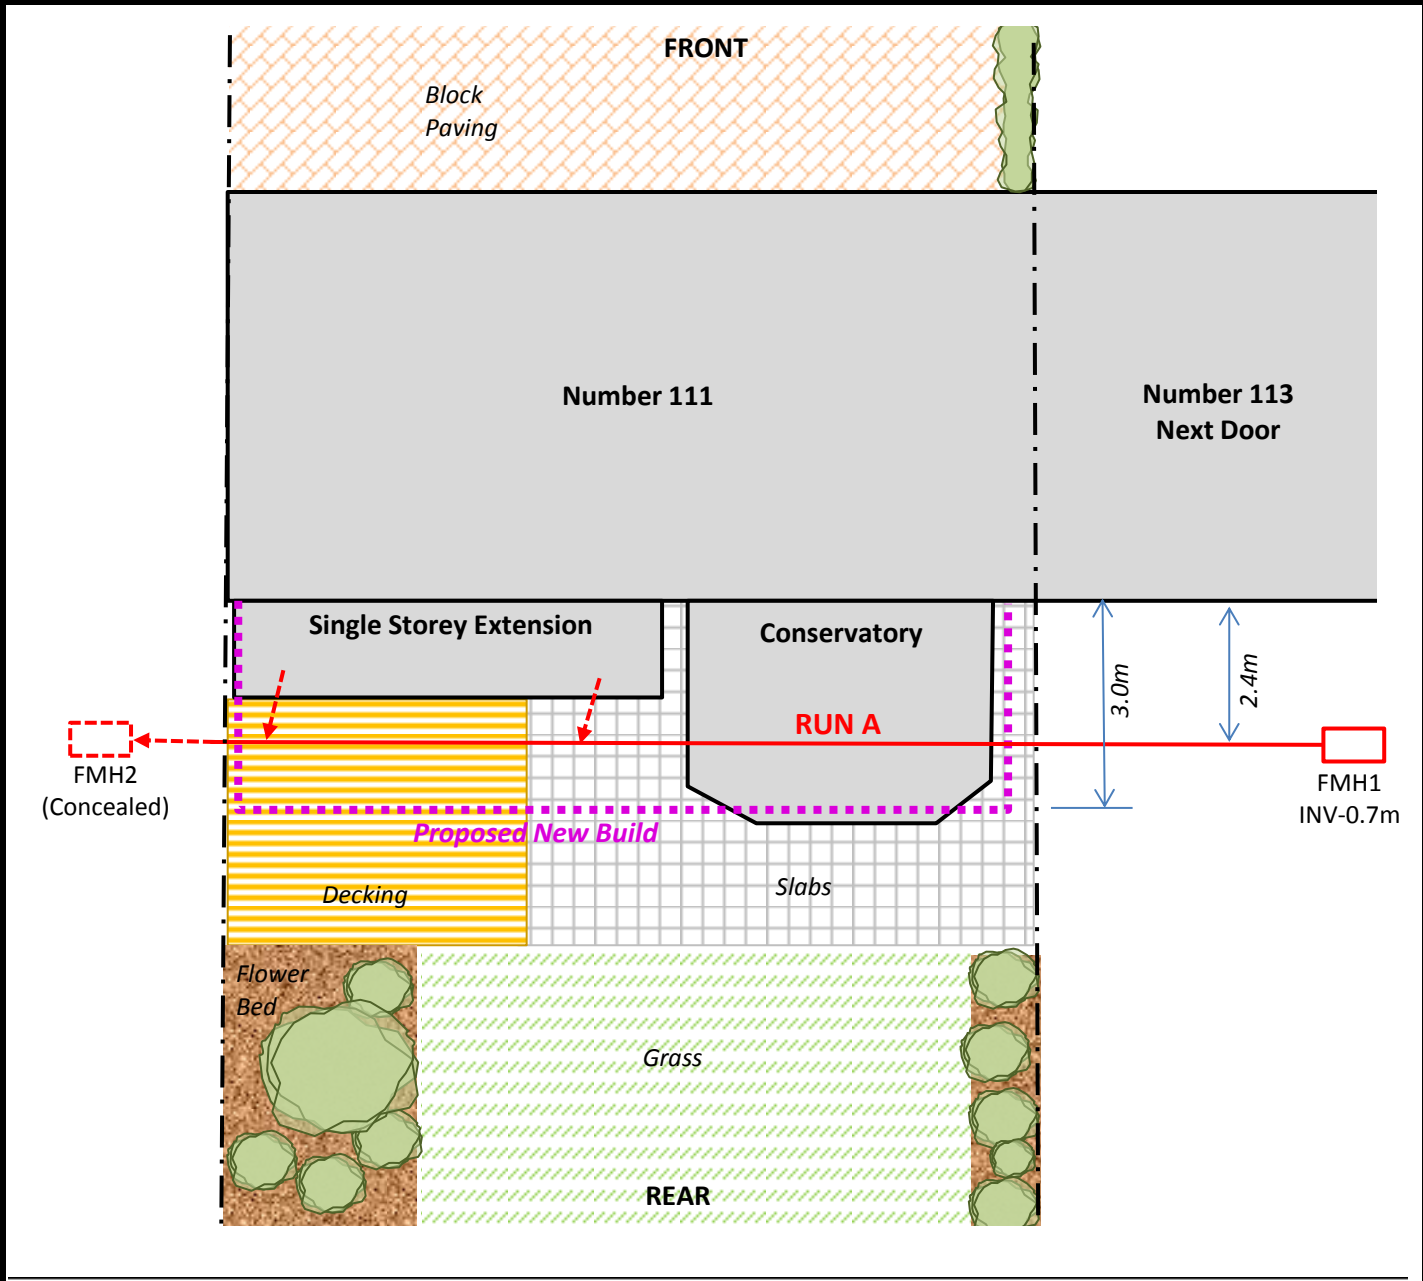
RUN A	Start From :	FMH1	Finish at :	Boundary	Pipe Ø:	100mm
	Invert Level (m):	0.7	Invert Level (m):	N/A	Material:	Clay
FOUL	Condition grade:	B	Direction:	Downstream	Responsibility:	Local Authority
<i>Distance</i>	<i>Code</i>	<i>Remarks</i>				
0.00	SN	Start Node from Boundary of No 150 to 148				
0.00	WL	Water Level 0%				
2.50	REM	Remark - At boundary line to number 148				
6.58	CM	Cracks Multiple				
7.50	JN	Junction at 3 o'clock				
8.97	MC	Material of drain changes at this point to Plastic				
9.10	JN	Junction at 3 o'clock				
9.30	MC	Material of drain changes at this point to Clay				
9.50	FN	Finish Node at Boundary

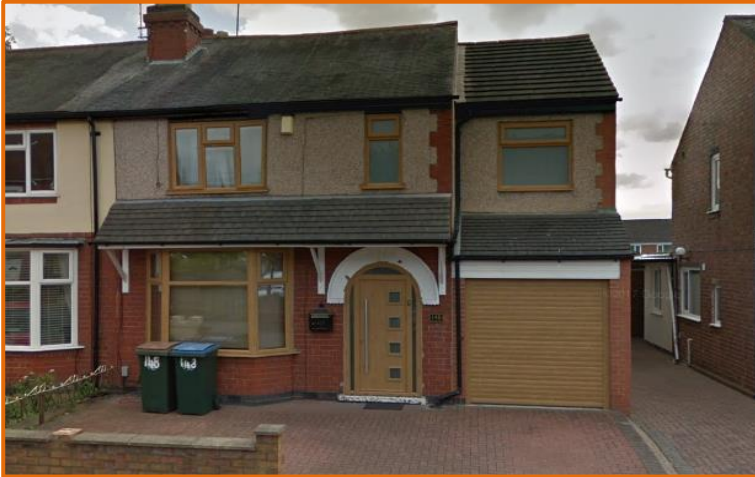
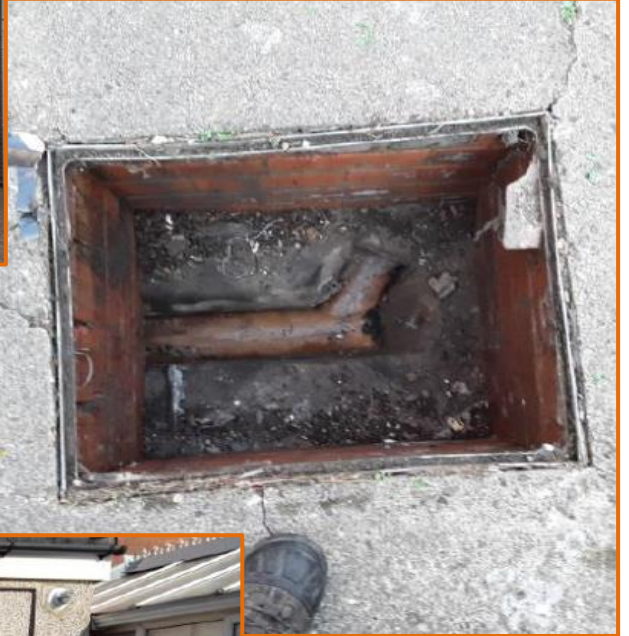
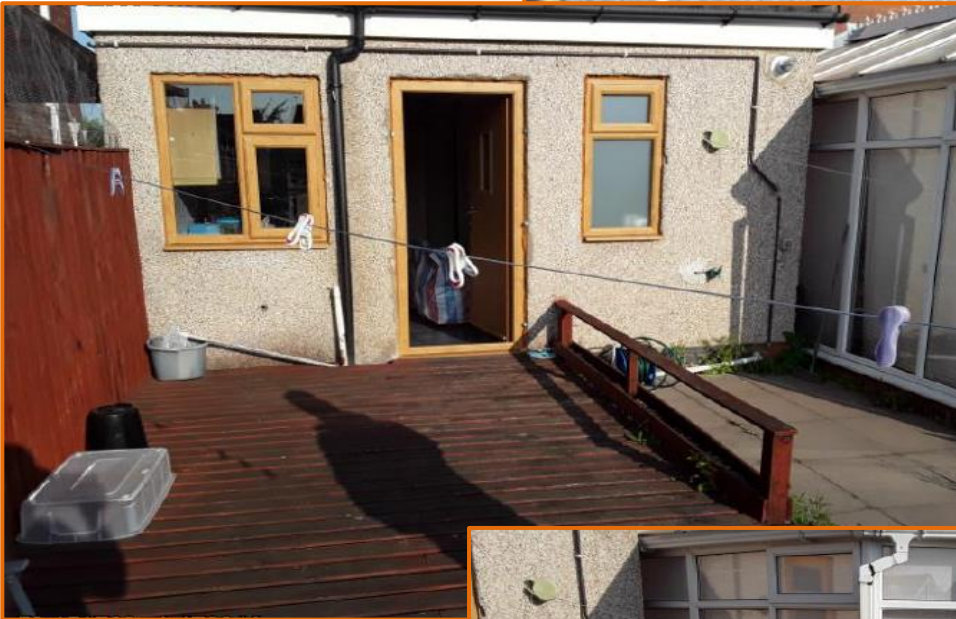
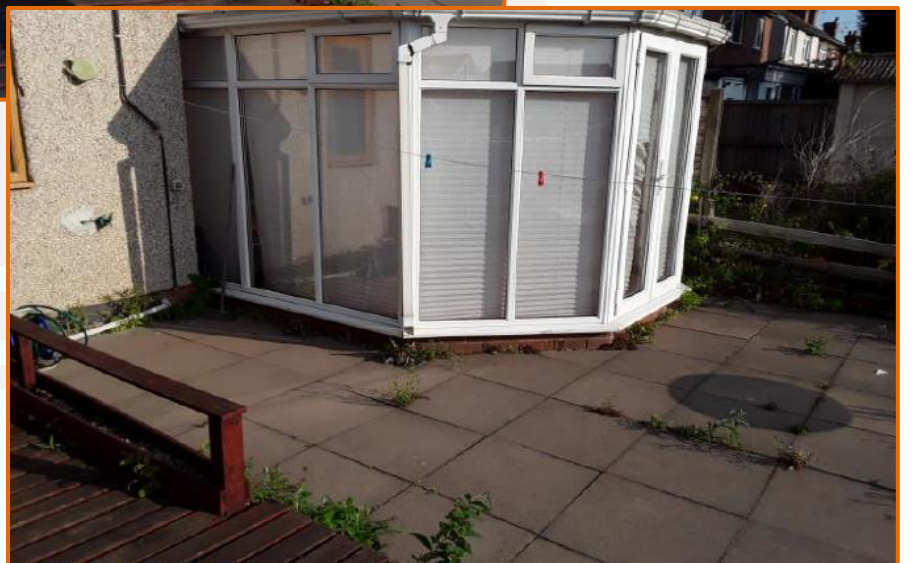
RUN A Multiple Cracks at 6.58m

CCTV Survey Result: Structural Damage - Multiple Cracks at 6.58m

Condition Grade: B

1) To prepare the drain line and insert 1x (100mmØ) resin patch liner to cover defect at 6.58m.
