# Drainage Report

**24 Example Street  
Birmingham  
B12 3PP**

CCTV Survey Report : 21/03/22

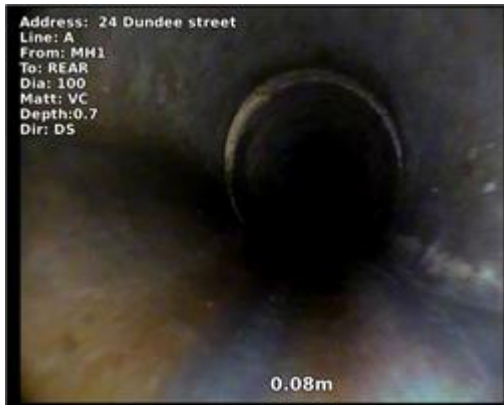
Pos	Video Ref	Code	Description	Image
00.00m		MH	Start node type, manhole MH1	<p>Image Provided - Ref: 0_0</p>

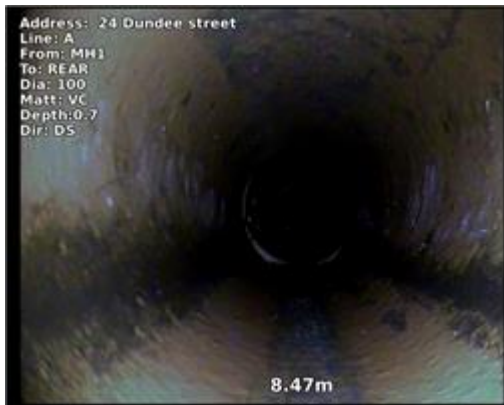
08.47m		OFF	Finish node type, outfall Boundary	<p>Image Provided - Ref: 0_9999</p>

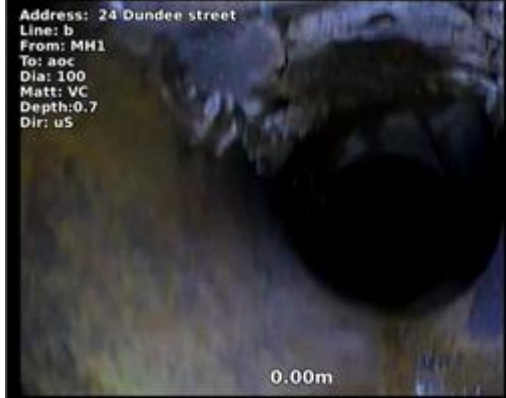
Pos	Video Ref	Code	Description	Image
00.00m		MH	Start node type, manhole MH1	<p>Image Provided - Ref: 1_0</p>

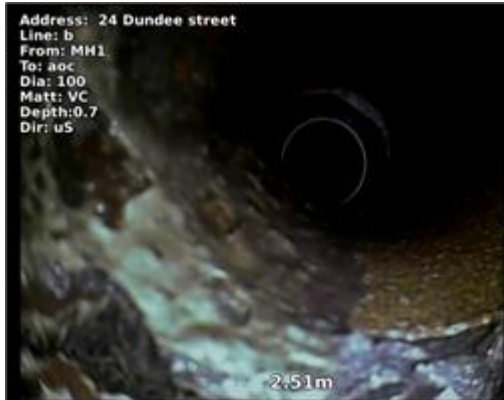
Pos	Video Ref	Code	Description	Image
02.51m		BRF	Finish node type, major connection without manhole WC	<p>Image Provided - Ref: 1_9999</p>

- 1) Excavate and replace rest bend at WC
- 2) Excavate and replace 1m of pipework
- 3) Install up to 2m of flexi liner to cover defects
- 4) Back-fill, reinstate and dispose of waste

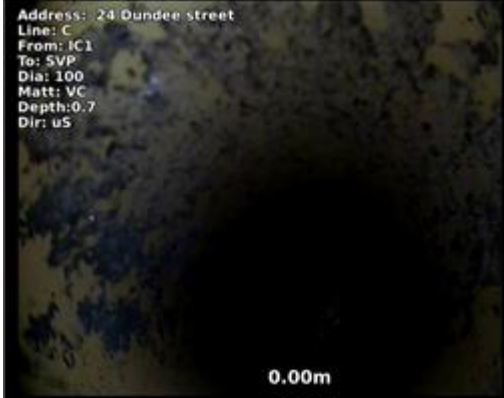
Pos	Video Ref	Code	Description	Image
00.00m		IC	Start node type, inspection chamber IC1	<p>Image Provided - Ref: 2_0</p>

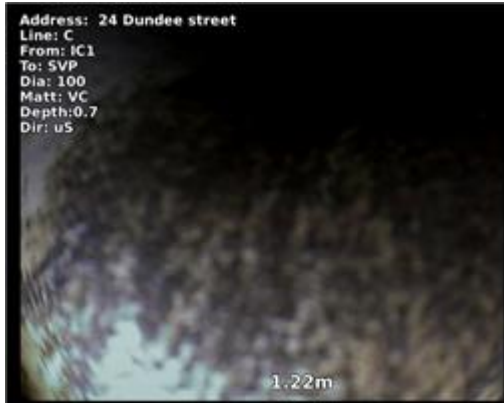
Pos	Video Ref	Code	Description	Image
01.22m		BRF	Finish node type, major connection without manhole SVP	<p>Image Provided - Ref: 2_9999</p>

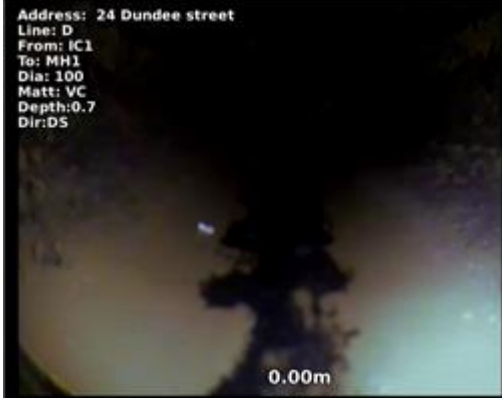
Pos	Video Ref	Code	Description	Image
00.00m		IC	Start node type, inspection chamber IC1	<p>Image Provided - Ref: 3_0</p>

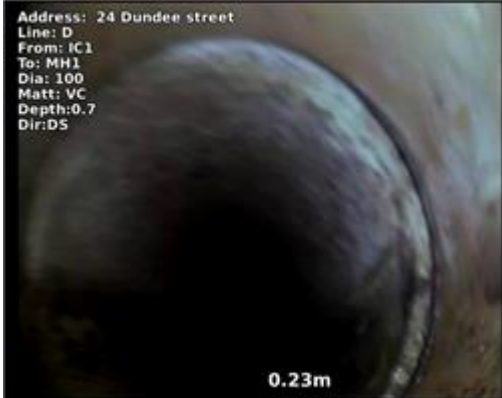
<p>Address: 24 Dundee street Line: D From: IC1 To: MH1 Dia: 100 Matt: VC Depth:0.7 Dir:DS</p> <p>0.00m</p>
00.00m	0:00:00	WL	Water level: 0% Height/Diameter	
00.23m	0:00:02	MCVC	Material of pipe changes to Vitrified Clay (i.e. all clayware)	<p>Image Provided - Ref: 3_2</p>

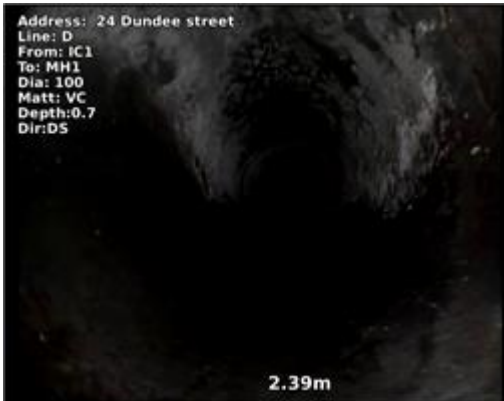
02.39m	0:00:10	JN	Junction at 03 o'clock: 100mm Diameter	<p>Image Provided - Ref: 3_3</p>

- 1) Install up to 5m of flexi liner (minding the junction at 2.39m) to cover defects
